Subject: **Suspected Asbestos Containing Building Materials Survey and Limited Lead-Based Paint Inspection Report**
Former Monroe Street Firehouse
215 Monroe Street, Fairmont, Marion County, West Virginia
Brownfield Assessment Grant Number BF-963604-01-0
Environmental Standards Project Number: 20198730

Suspect Asbestos Containing Building Materials Survey

**Fairmont Firehouse
211 Monroe Street
Fairmont, WV 26554**

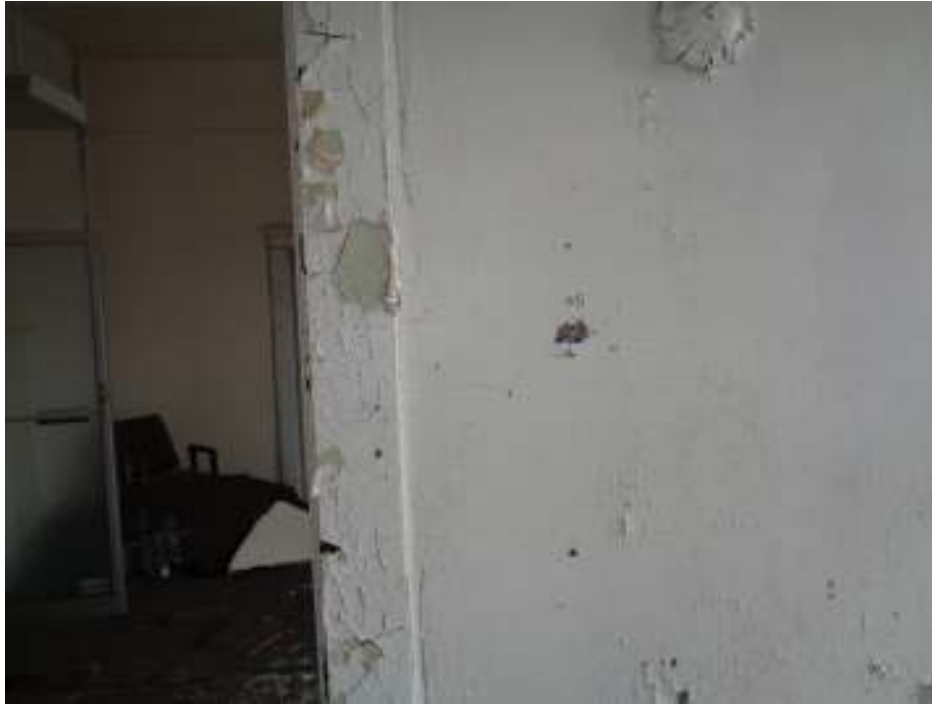
Photo of the ACM plaster located on the wall in Room 58.

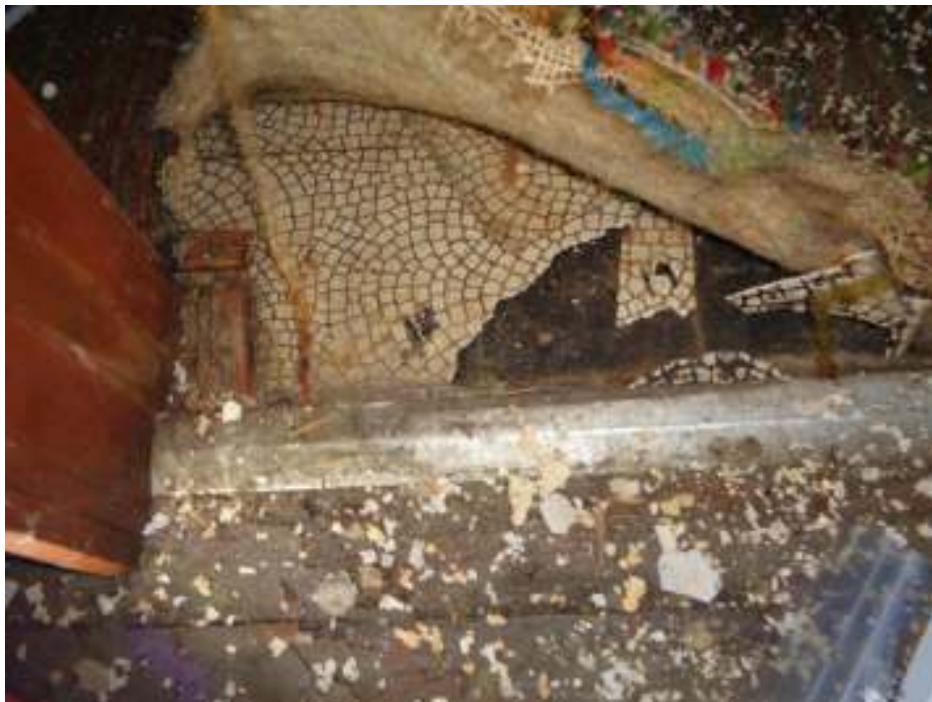
Photo of the ACM white pebble pattern vinyl sheet flooring located in Room 73.

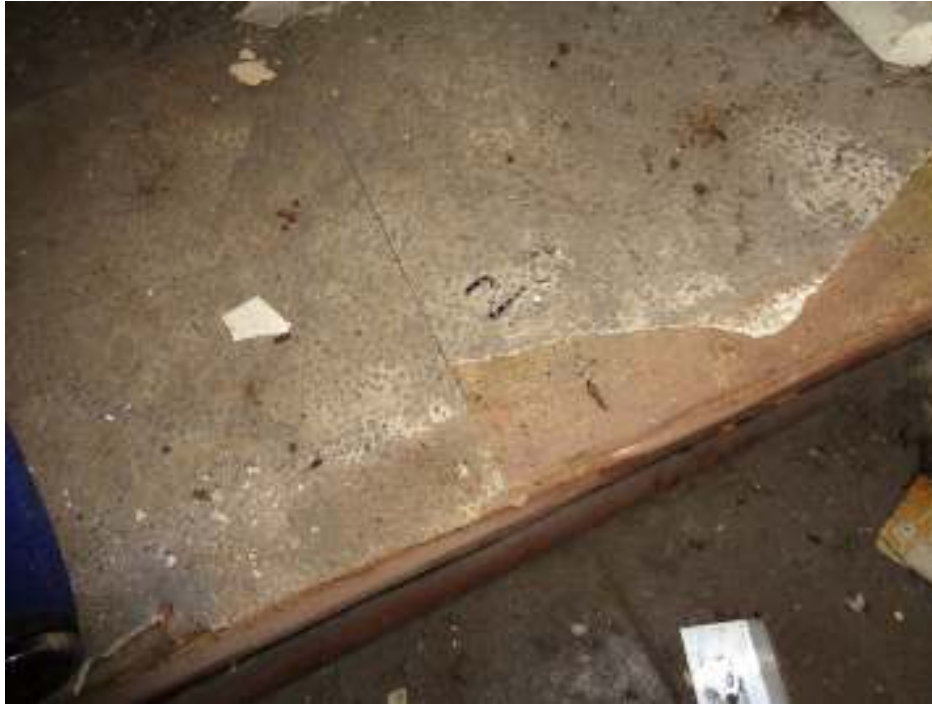
Photo of the ACM white pitted vinyl sheet flooring located in Room 78.

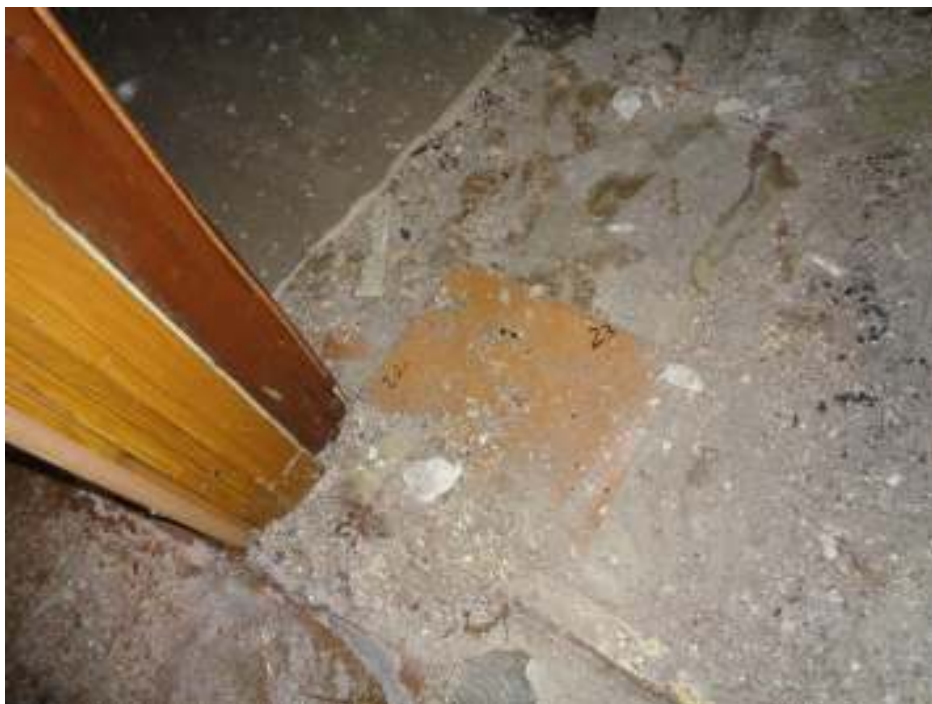
Photo of the ACM green vinyl sheet flooring (top layer) located in Room 79.

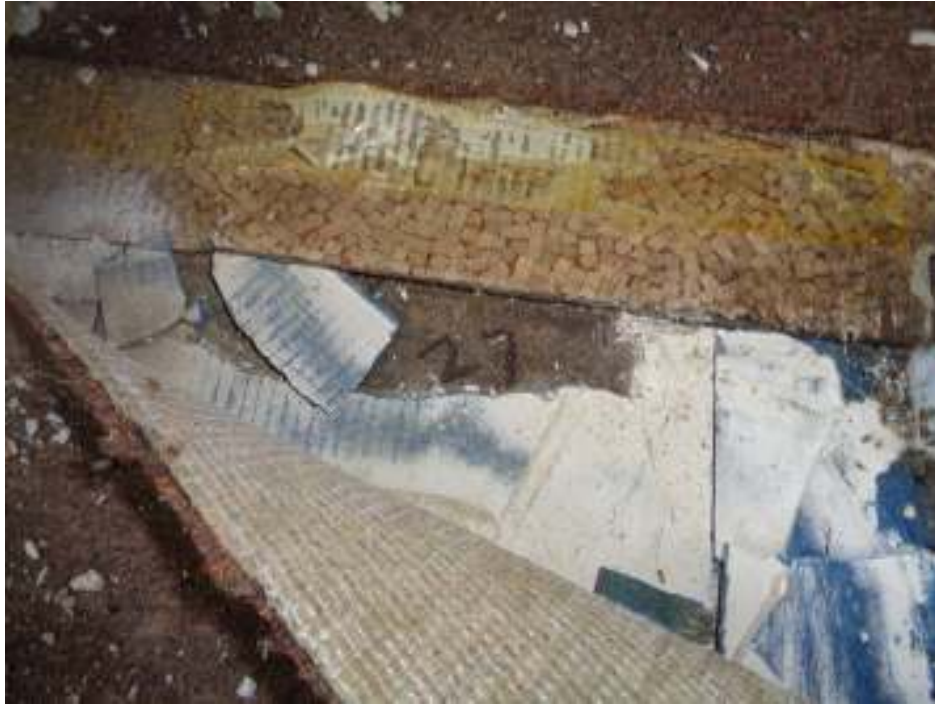
Photo of the ACM blue floor tile located under the carpet in Room 62.

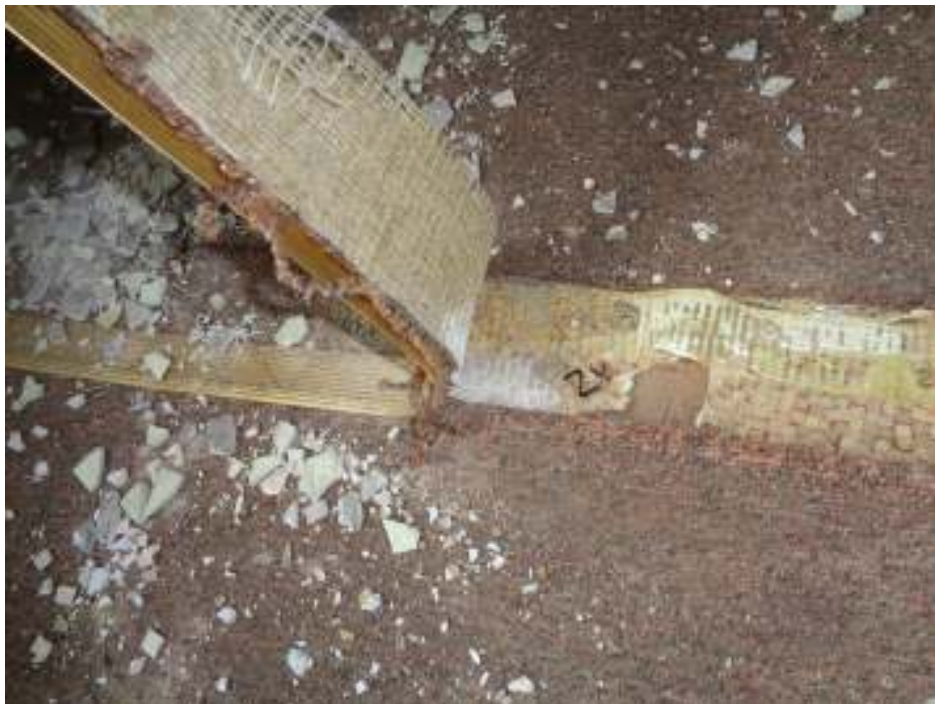
Photo of the ACM pebble pattern vinyl sheet flooring located under the carpet in Room 63.

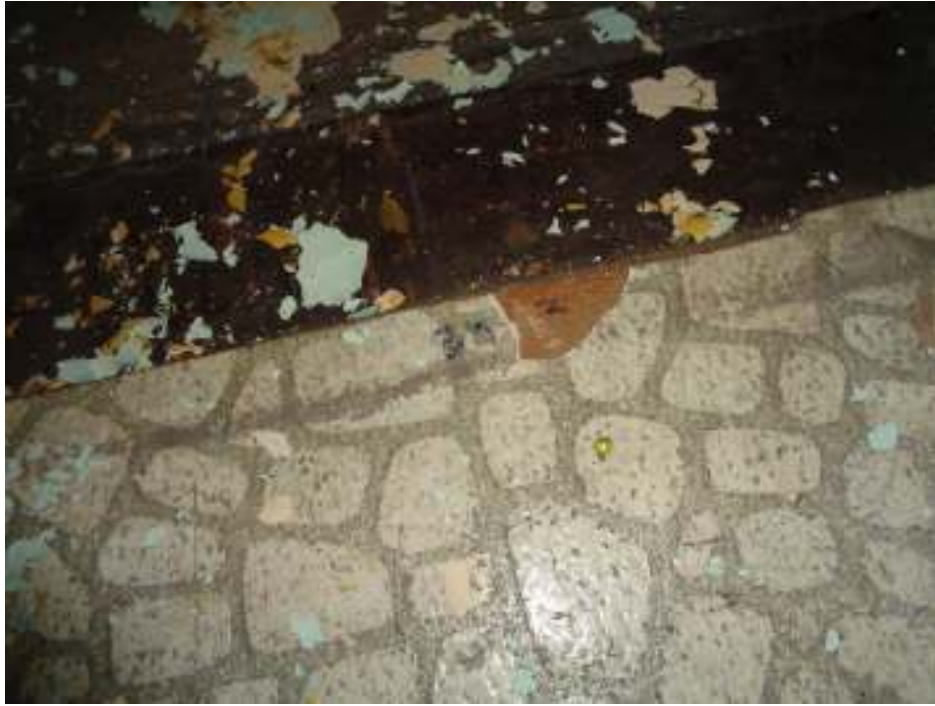
Photo of the ACM stone pattern vinyl sheet flooring in Room 47.

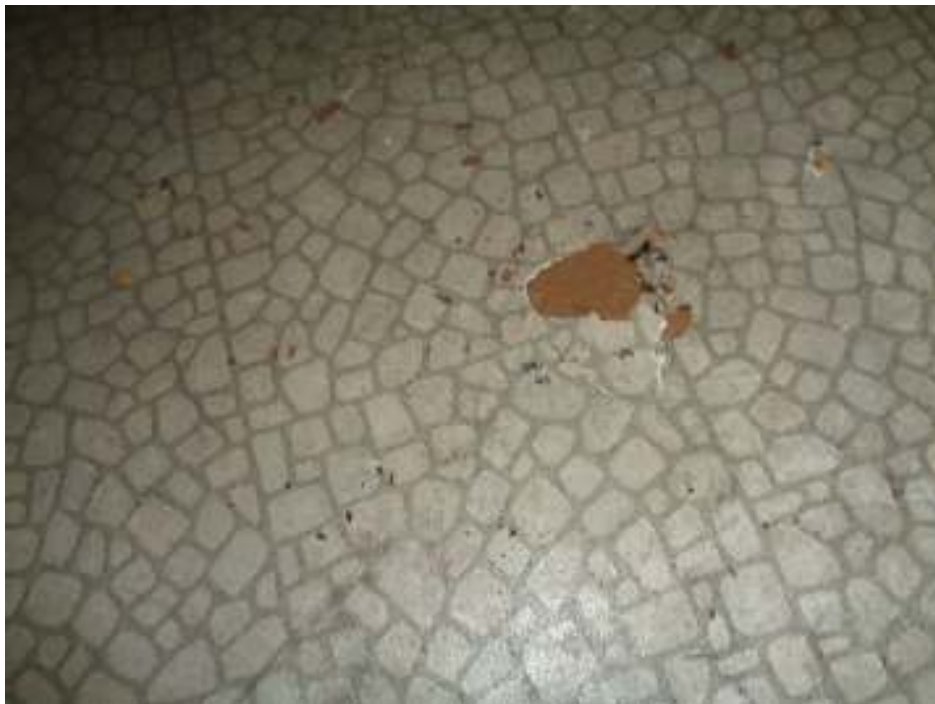
Photo of the ACM brown floor tile located under the ACM pebble pattern vinyl sheet flooring located in Room 47.

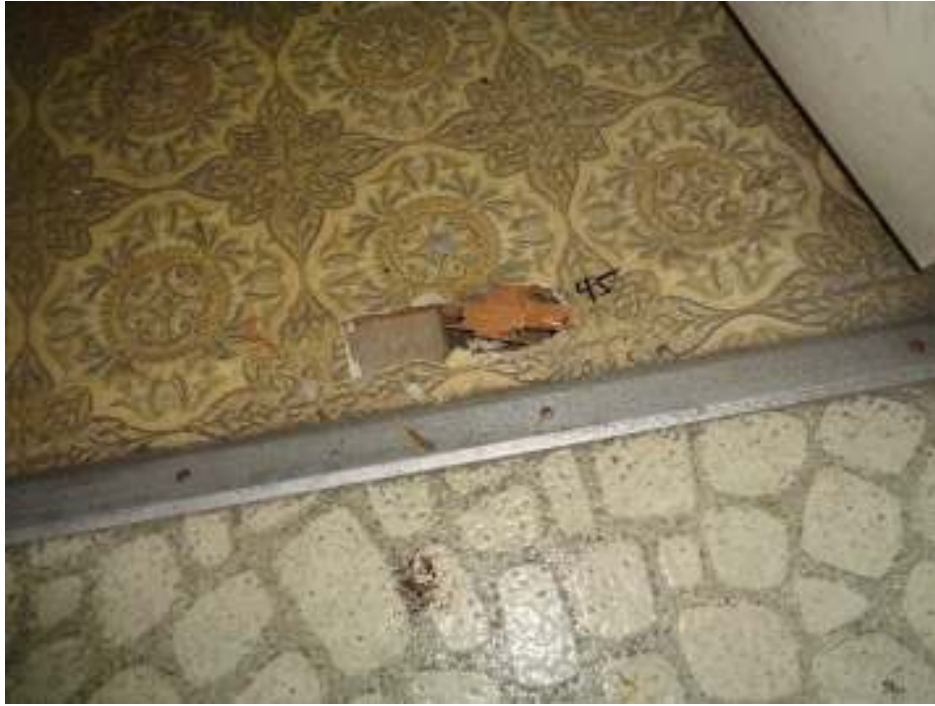
Photo of the ACM green/white vinyl sheet flooring located in Room 53.

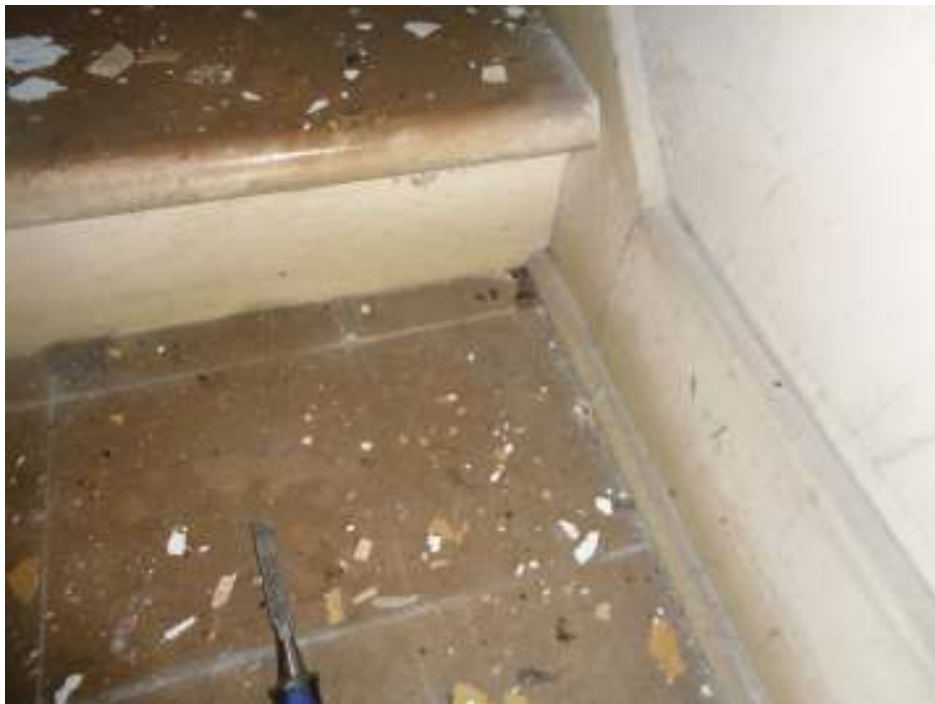
Photo of the ACM tan floor tile located in Stairwell 4th-3rd Landing.

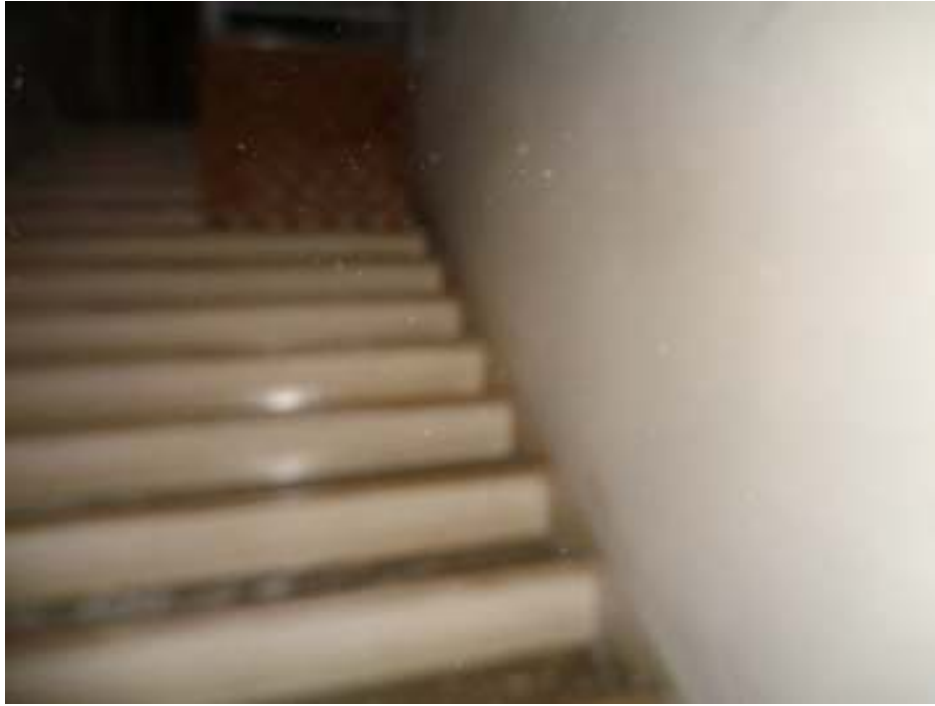
Photo of the ACM tan rubber floor tile located on the tread of Stairwell 4th-3rd.

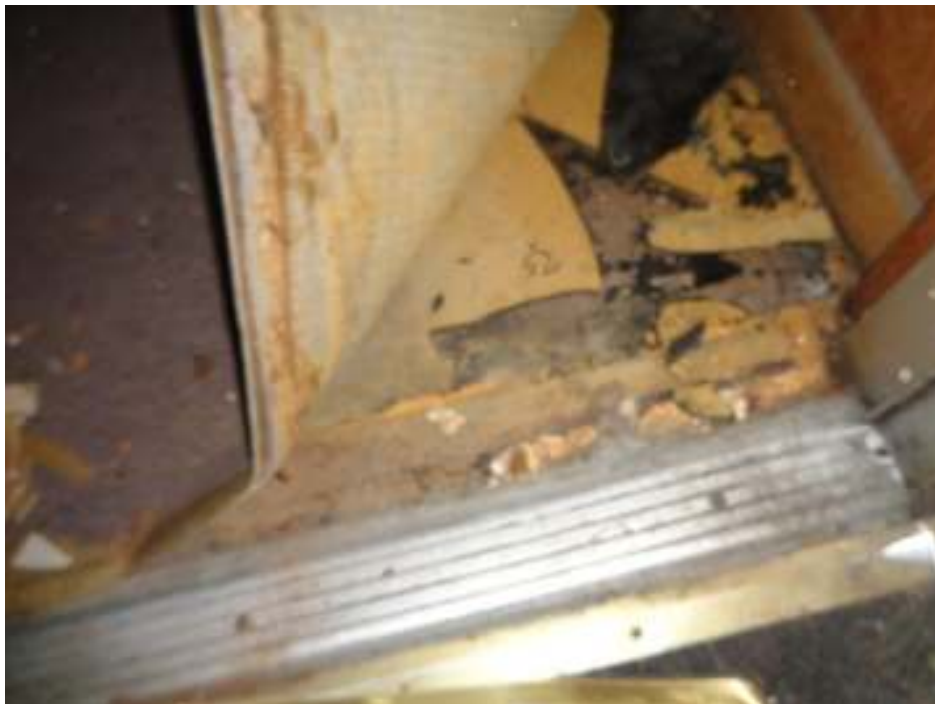
Photo of the ACM black floor tile and mastic located under the carpet in Room 30.

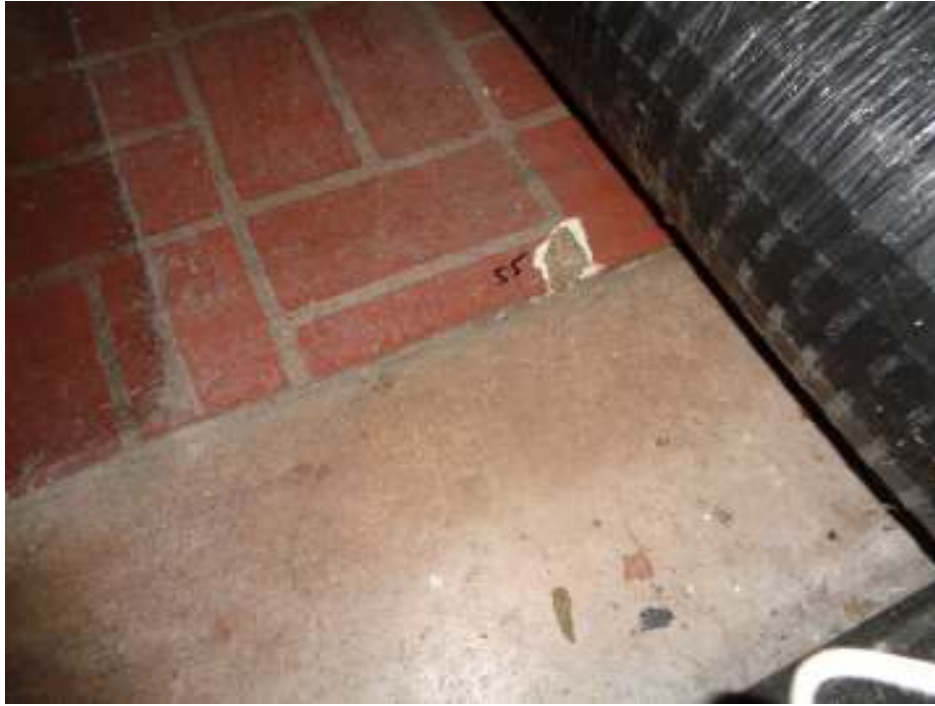
Photo of the ACM brick pattern vinyl sheet flooring located in toward the front of Room 30.

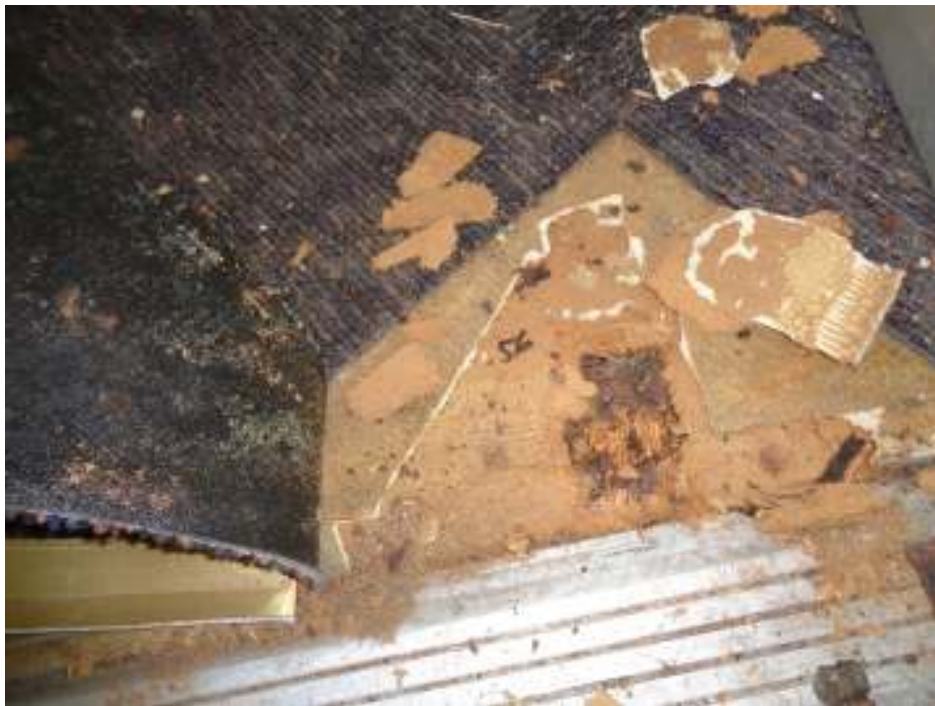
Photo of the ACM tan floor tile located under the carpet in Room 32.

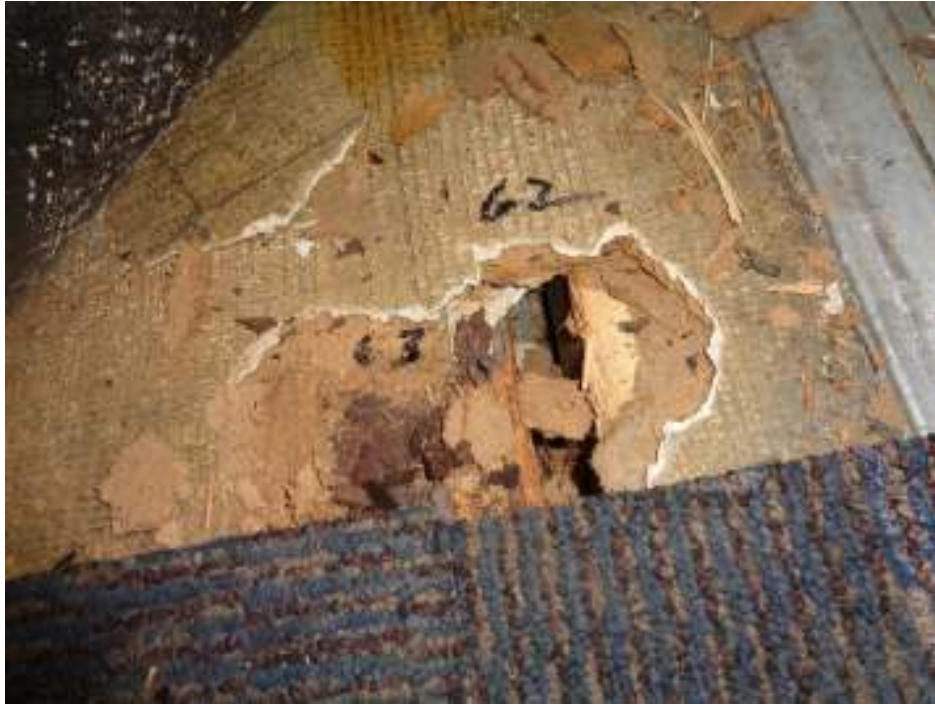
Photo of the ACM tan floor tile located under the carpet in the hallway of Room 32.

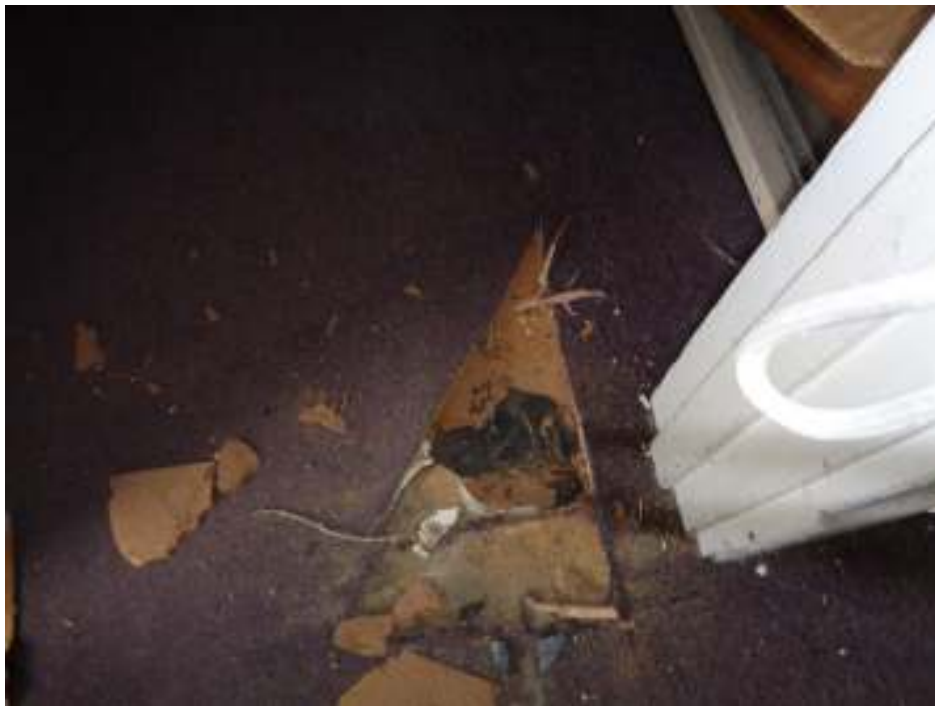
Photo of the ACM maroon floor tile and black floor tile located under the carpet and tan floor tile in Room 37.

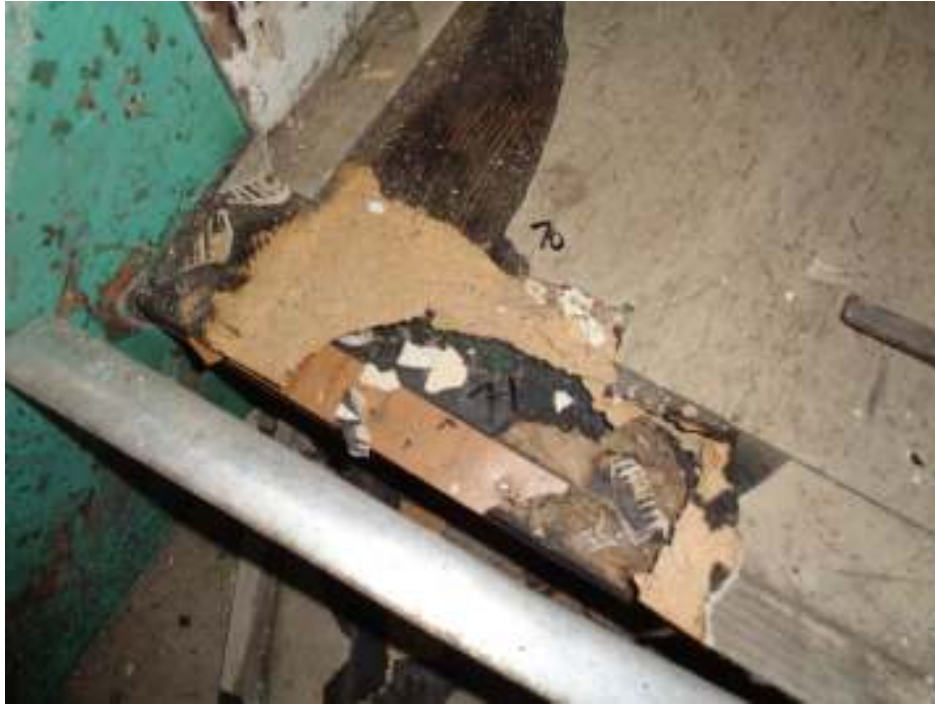
Photo of the ACM grey floor tile (top layer) located in Room 46.
